INDOOR AIR QUALITY ASSESSMENT

**James L. Mulcahey Middle School
28 Clifford Street
Taunton, Massachusetts**

Prepared by:
Massachusetts Department of Public Health
Bureau of Environmental Health
Indoor Air Quality Program
March 2008

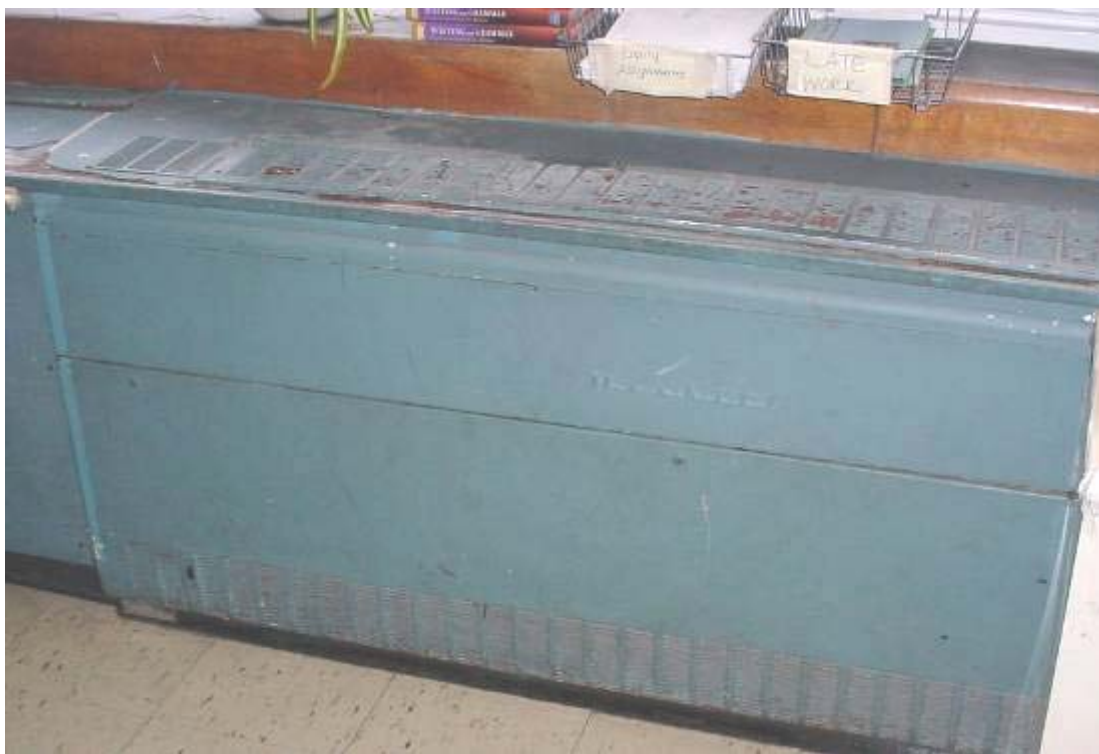
Picture 1

Fresh air in classrooms is supplied by unit ventilator (univent) systems (Pictures 1 and 2). A univent draws air from the outdoors through a fresh air intake located on the exterior wall of the building (Pictures 3 and 4) and returns air through an air intake located at the base of the unit ([Figure 1](#)). Fresh and return air are mixed, filtered, heated and provided to classrooms through an air diffuser located in the top of the unit. Univents are original to the each portion of the building (20 + years old for the 1980s wings; 50 + years in the original building). Efficient function of such equipment can be difficult to maintain since compatible replacement parts are often unavailable. Univents were found operating weakly or deactivated or non-functional in a

Original 1950s Vintage Univent

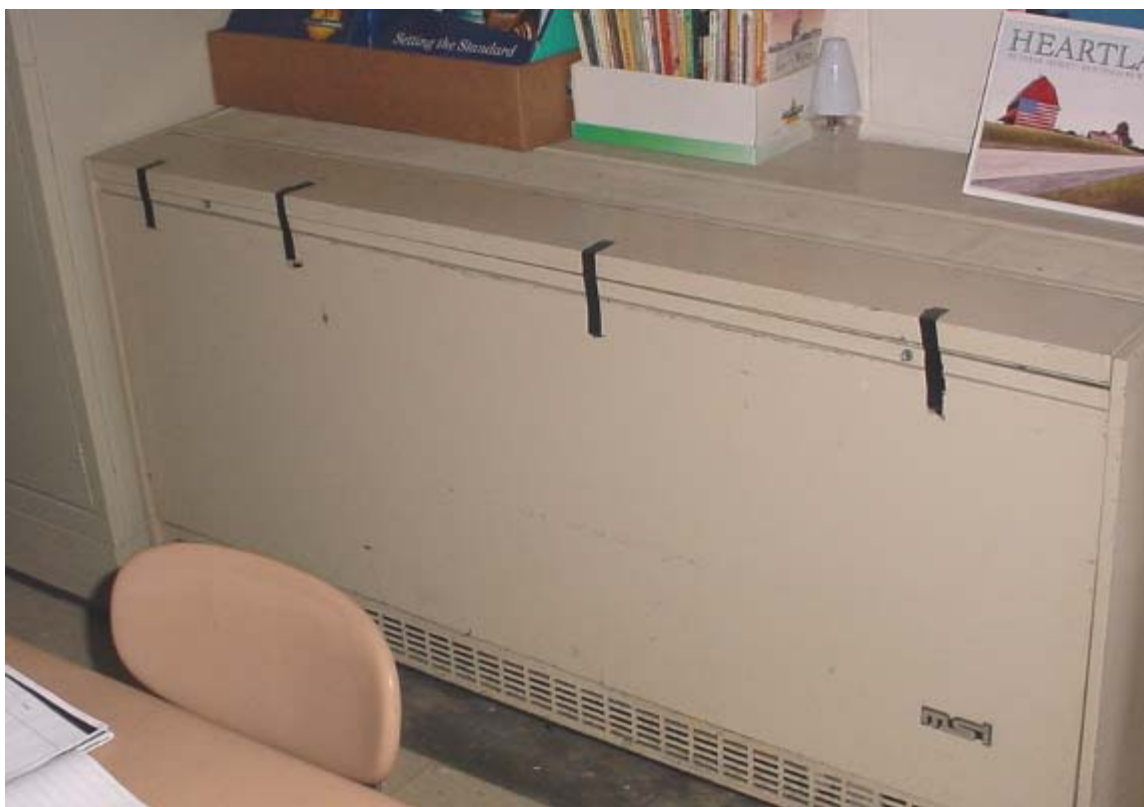
Picture 2

1980s Vintage Univent, Note Masking Tape Securing Front Cover

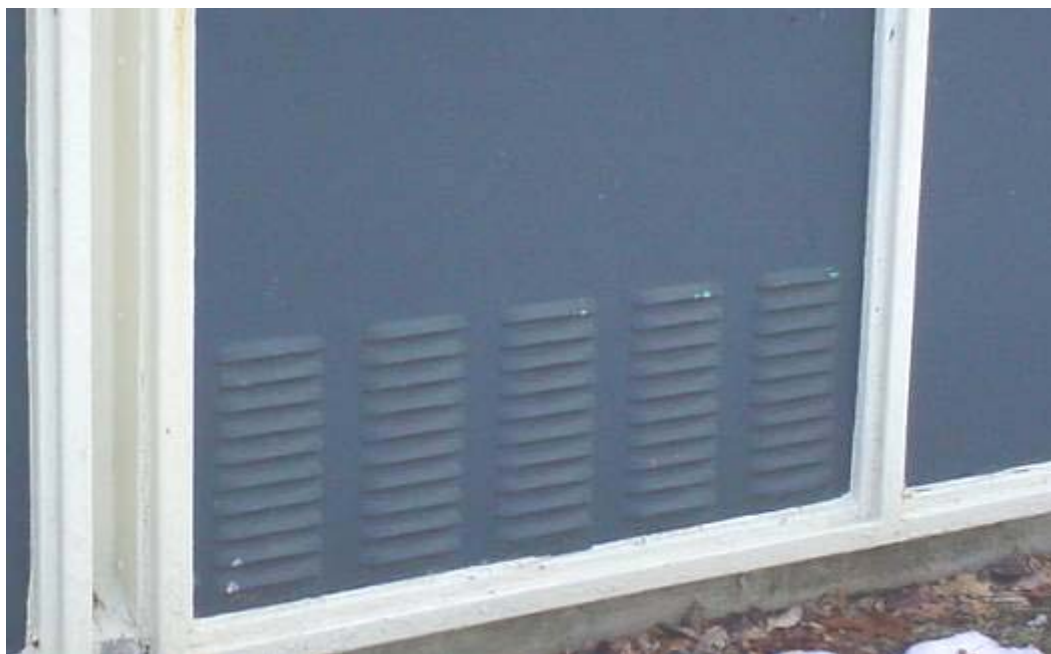
Picture 3

Univent Fresh Air Intake for 1950s Unit

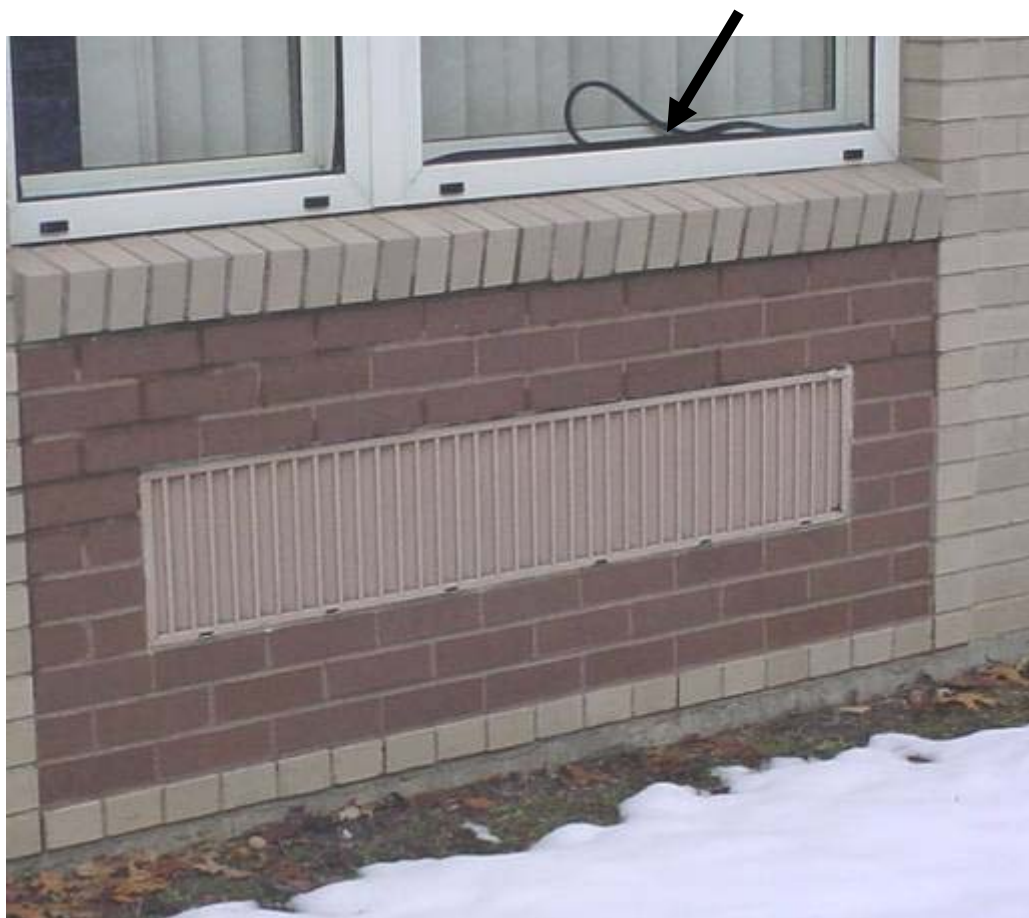
Picture 4

Univent Fresh Air Intake for 1950s Unit, Also Note Loosened Strip Caulking for Windows

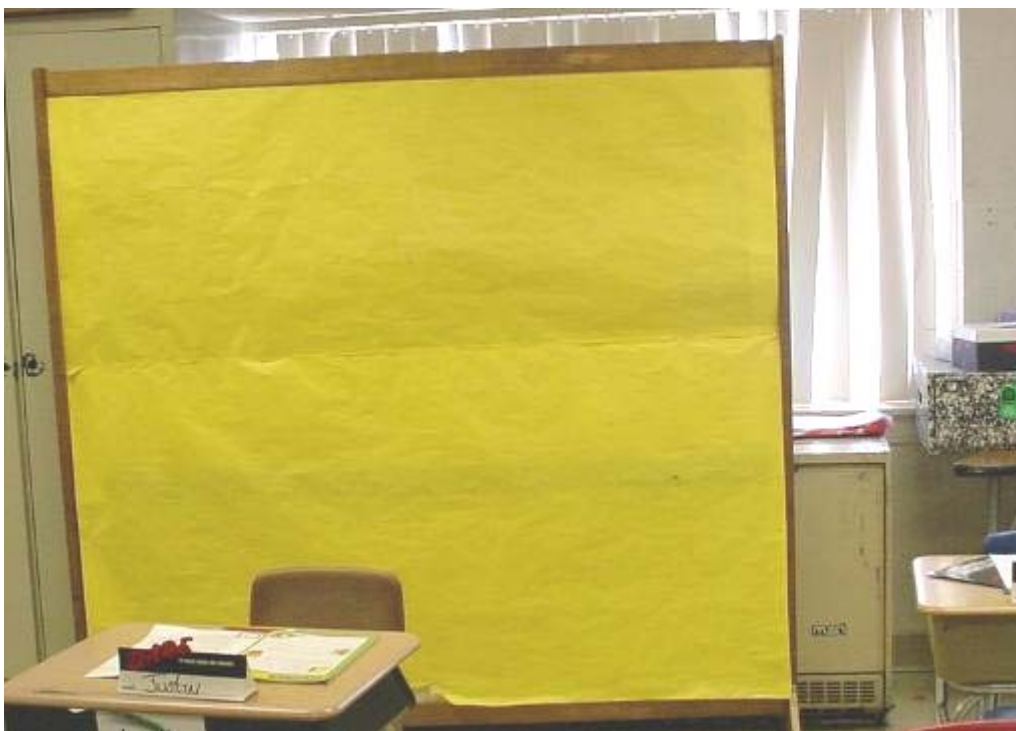
Picture 5

number of areas. Therefore, no (or limited) means to provide mechanical ventilation existed in these classrooms at the time of the assessment. Univents were found obstructed by various items (Picture 5). In order for univents to provide fresh air as designed, intakes/returns must remain free of obstructions. Importantly, these units must remain “on” and be allowed to operate while rooms are occupied.

Screen Obstructing Univent Airflow

4. Remove all blockages from univents and exhaust vents to ensure adequate airflow.
5. Ensure classroom doors remain closed to maximize air exchange.
6. Consider adopting a balancing schedule of every 5 years for all mechanical ventilation systems, as recommended by ventilation industrial standards (SMACNA, 1994).

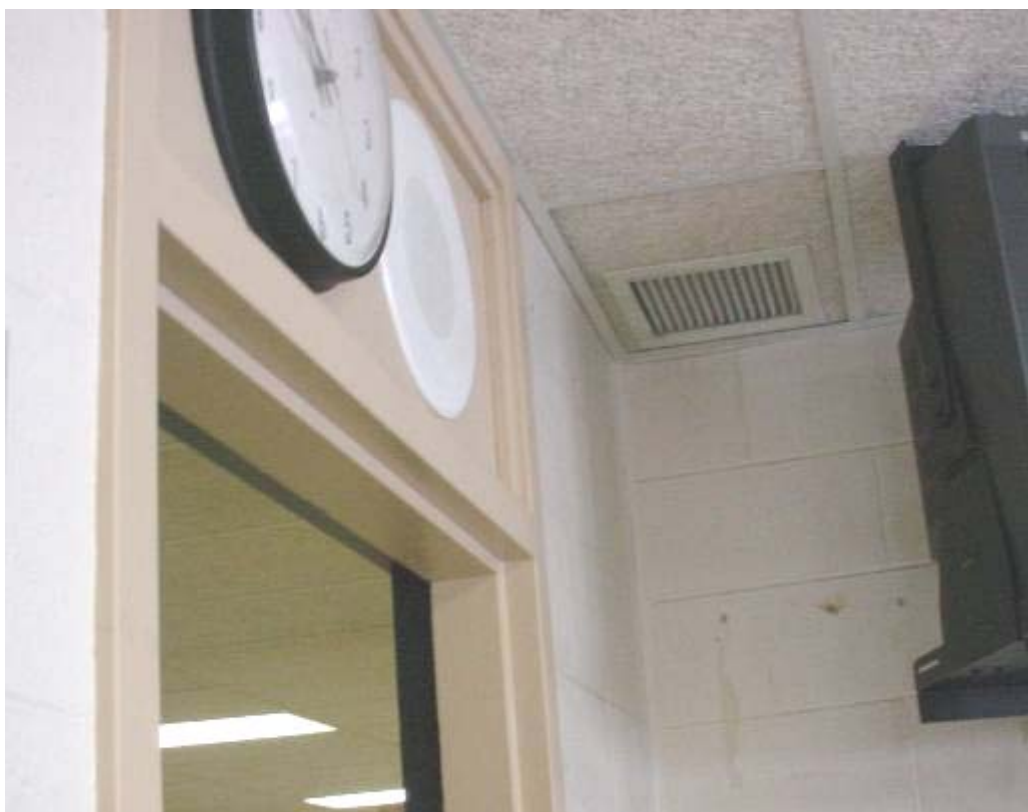
Picture 6

Exhaust ventilation in classrooms is provided by wall or ceiling vents ducted to rooftop motors (Pictures 6 through 9). In a previous correspondence, Adam Vickstrom of the TBOH discovered during a site visit that the exhaust ventilation system in classroom 37 was deactivated, limiting air circulation. At the time of the BEH assessment, these exhaust vents were reactivated and operating. Exhaust vents were functional throughout the school; however, a number of them were obstructed (Pictures 10 and 11). As with univents, exhaust vents must be activated and remain free of obstructions. In several classrooms, exhaust vents are located near hallway doors (Pictures 6 and 7). When classroom doors are open, exhaust vents will tend to draw air from the hallway instead of the classroom, reducing the effectiveness of the exhaust vent to remove common environmental pollutants. Without adequate supply and exhaust ventilation, excess heat and environmental pollutants can build up and lead to indoor air/comfort complaints.

Classroom Exhaust Vent, Note Proximity to (Open) Hallway Door

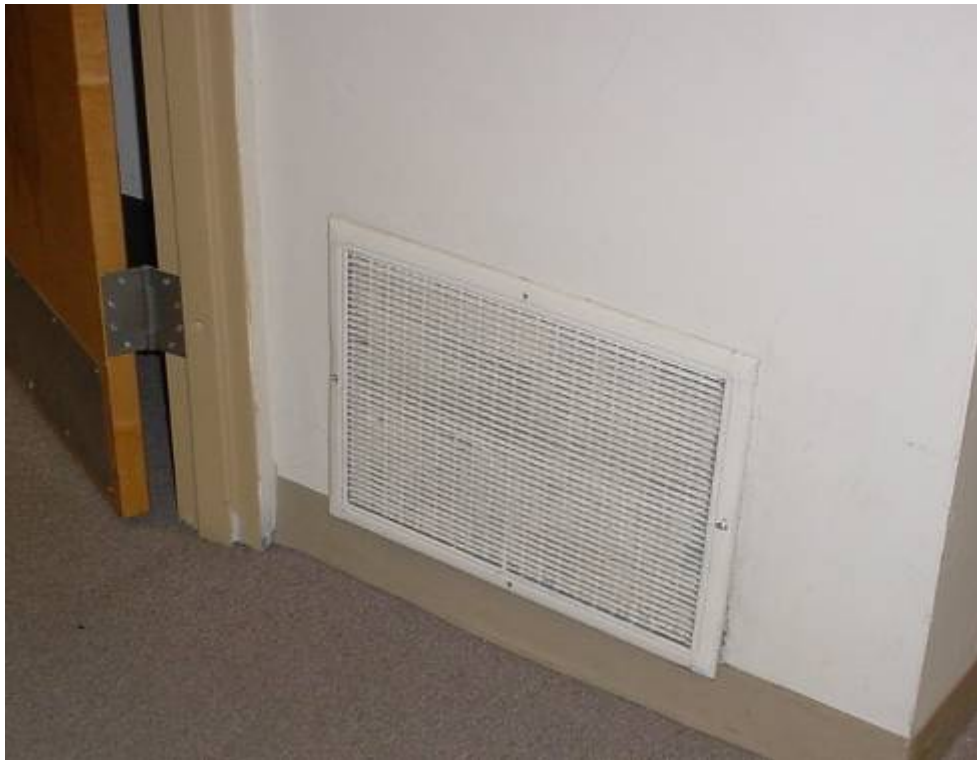
Picture 7

Wall-Mounted Exhaust Vent, Note Proximity to (Open) Hallway Door

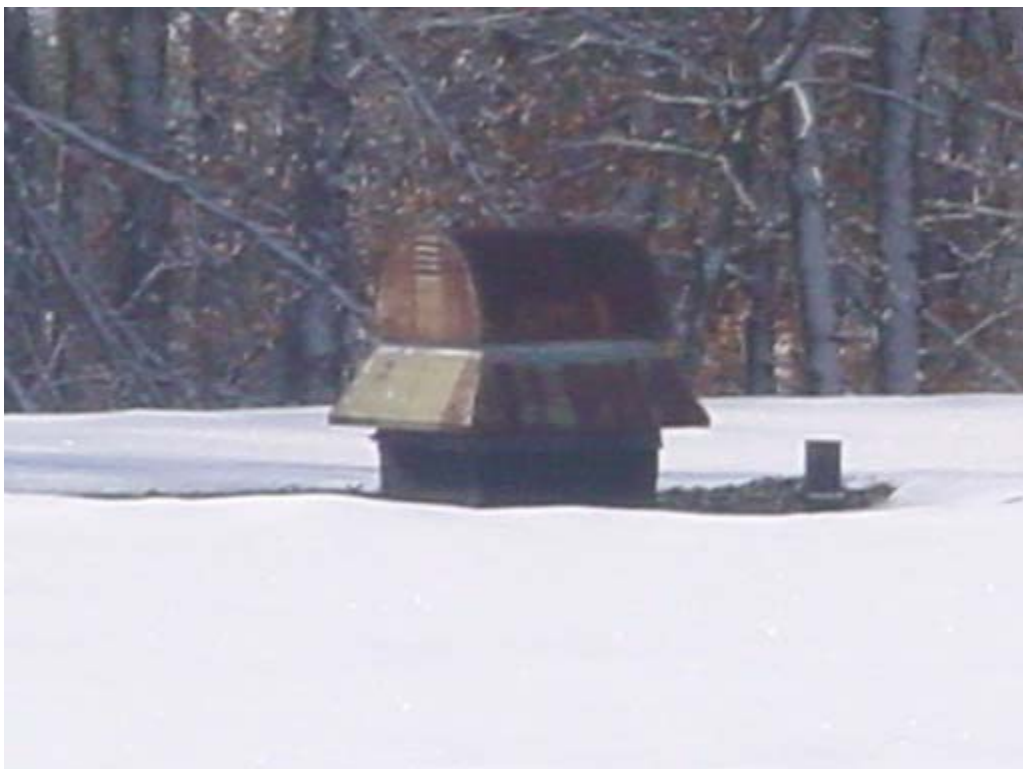
Picture 8

Rooftop Exhaust Motor

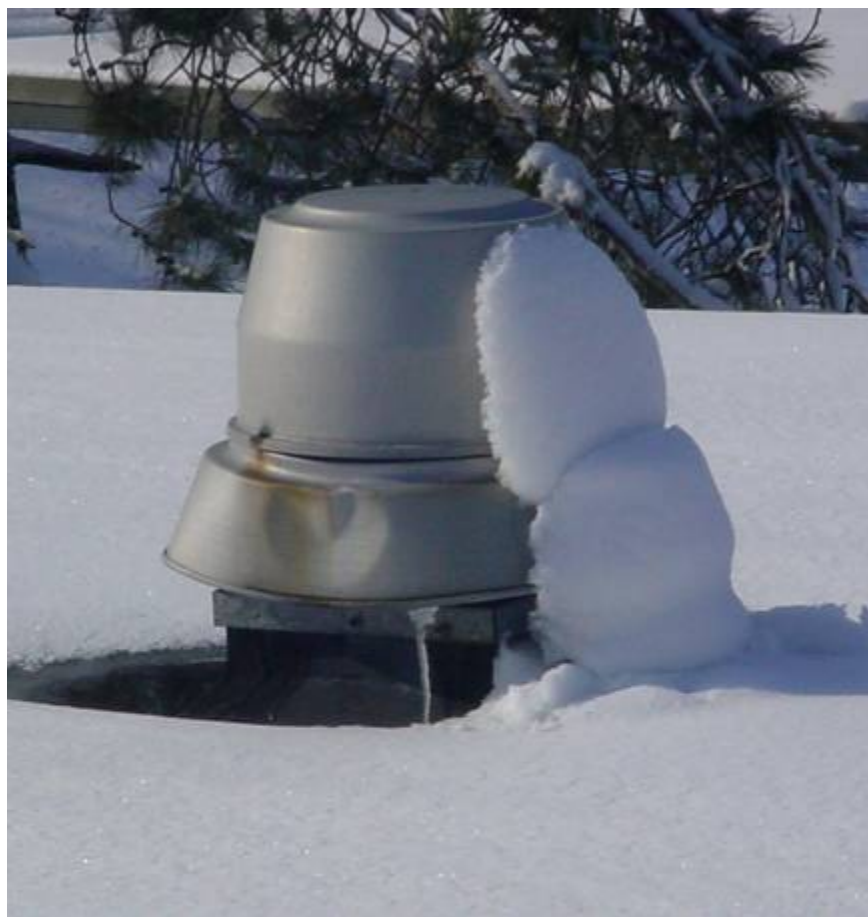
Picture 9

Rooftop Exhaust Motor

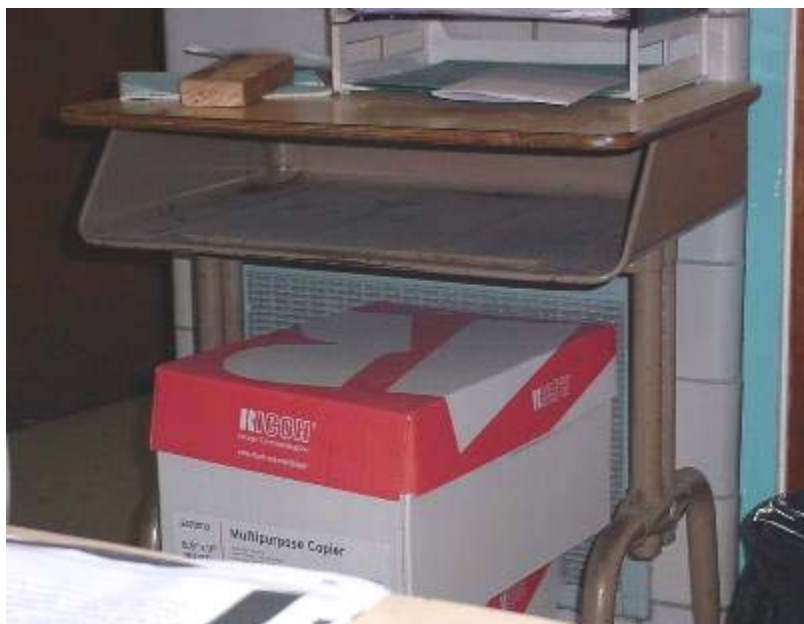
Picture 10

Exhaust Partially Obstructed by Boxes

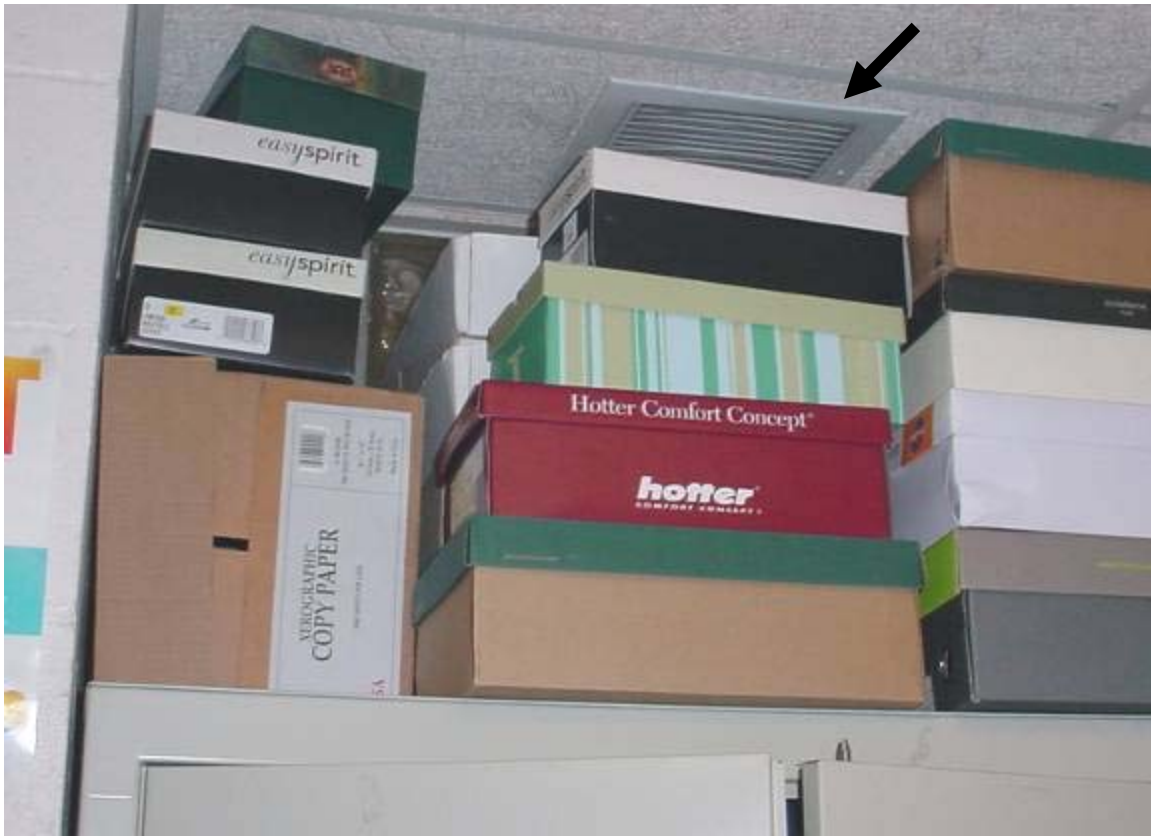
Picture 11

Ceiling-Mounted Exhaust Vent Partially Obstructed by Items

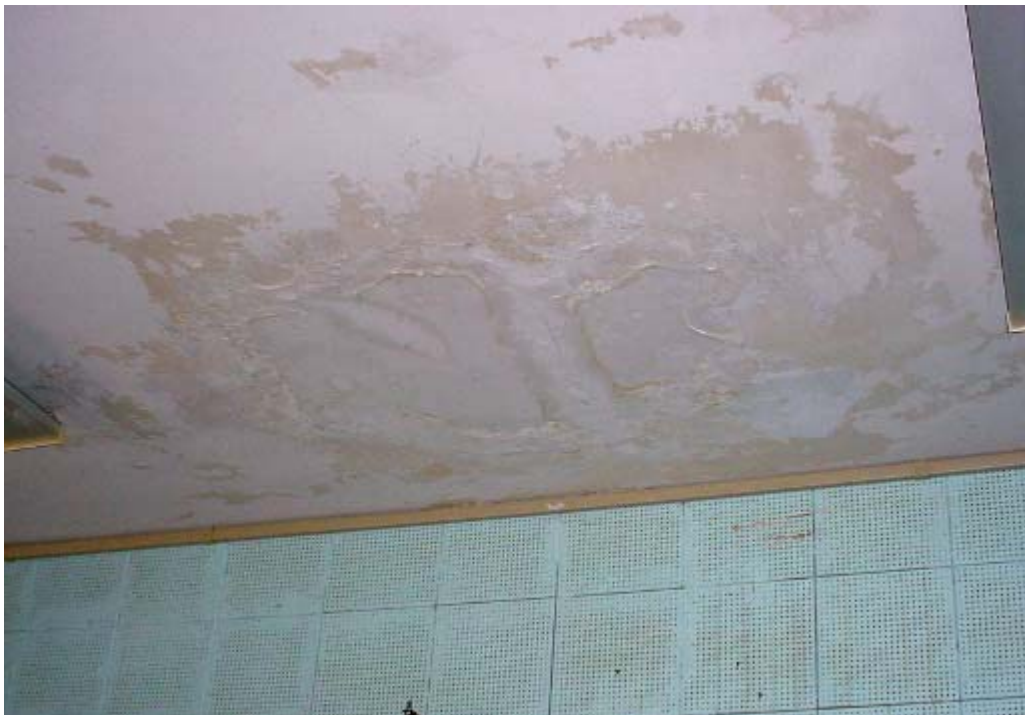
Picture 12

In order for building materials to support mold growth, a source of water exposure is necessary (e.g., roof/plumbing leaks). A previous roof leak reportedly occurred in the vicinity of classroom 29. Water damaged ceiling plaster and wall panels were observed in this area (Picture 12).

Water Damaged Ceiling Plaster and Wall Panels in Classroom 29

1. Remove water damaged portion of GW in classroom 29. This measure will remove actively growing mold colonies that may be present. Conduct remediation activities in a manner consistent with recommendations in “Mold Remediation in Schools and Commercial Buildings” published by the US Environmental Protection Agency (US EPA, 2001). This document can be downloaded from the US EPA website:
http://www.epa.gov/iaq/molds/mold_remediation.html.

2. Once work is completed, ensure that the area is thoroughly cleaned and disinfected with an appropriate antimicrobial. Dust and particulates resulting from remediation efforts should be wet mopped/wiped and/or vacuumed with a HEPA filtered vacuum cleaner.

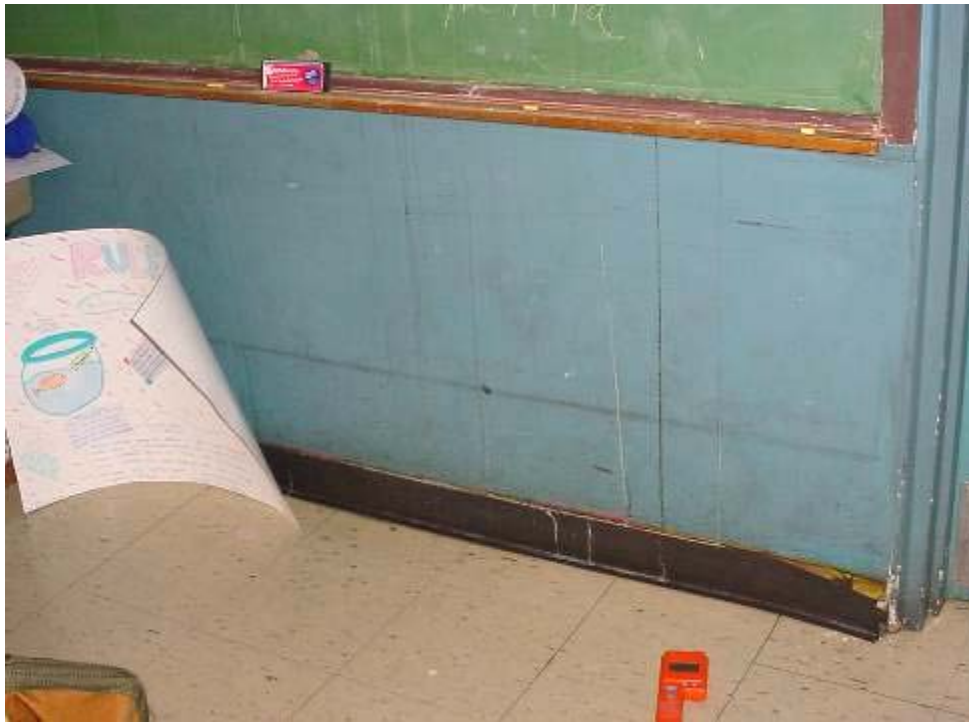
Picture 13

Identification and elimination of water moistening building materials is necessary to control mold growth. Materials with increased moisture content *over normal* concentrations may indicate the possible presence of mold growth. BEH staff conducted moisture testing of materials in a number of areas likely impacted by water damage. Ceiling plaster and wall panels in this area were found to have low (i.e., normal) moisture content at the time of the assessment (Table 1), indicating they were dry. However, elevated (i.e., saturated) moisture content and visible mold growth was observed behind vinyl wall covering directly below the area of leakage (Pictures 13 and 14). Vinyl wallpaper is a water impermeable material that can retain moisture.

Section of Gypsum Wallboard in Classroom 29 behind Vinyl Wallpaper Directly below Leak in Previous Picture

At the time of the assessment, Mr. Holmes recommended to Principal Christel Torres that she coordinate with the Taunton School Department maintenance department to schedule remediation of the water damaged/mold colonized materials and that in order to best protect occupants, any remediation of water-damaged/mold contaminated materials be done during unoccupied periods and in a manner consistent with recommendations in “Mold Remediation in Schools and Commercial Buildings” published by the US Environmental Protection Agency (US EPA, 2001). This information was subsequently communicated with the TBOH.

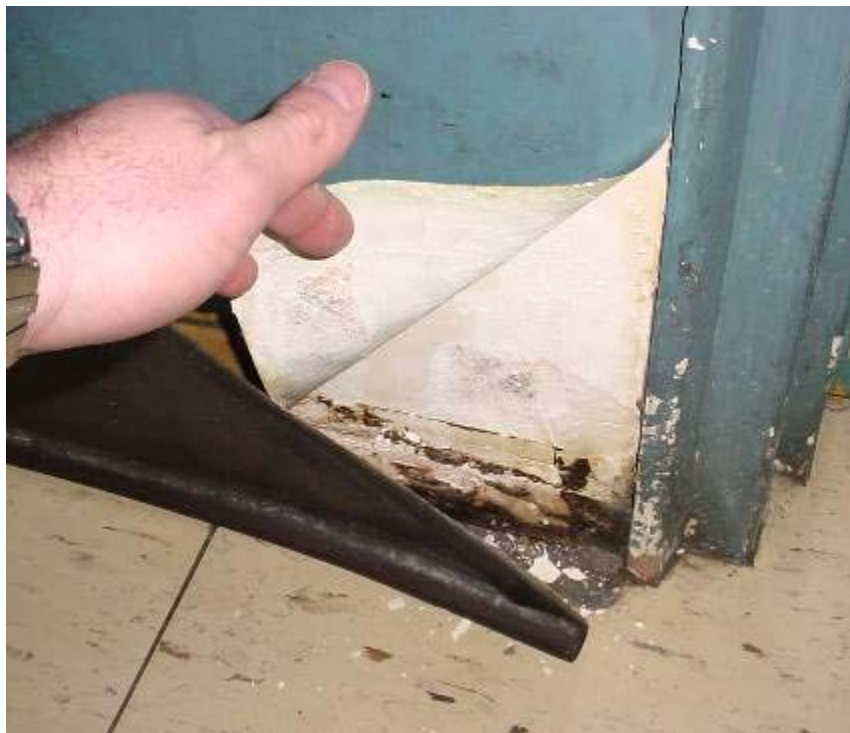
Picture 14

Close-up of Section of Gypsum Wallboard in Classroom 29 behind Vinyl Wallpaper Directly below Leak in Previous Picture, Dark Stains Indicate Mold Growth

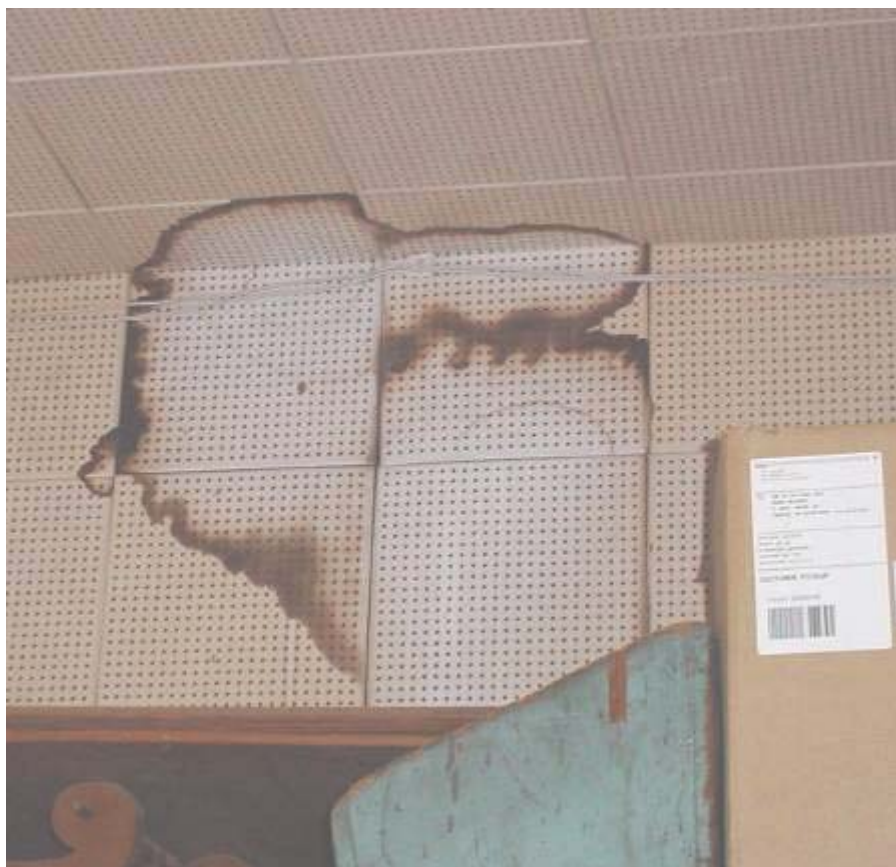
Picture 15

Numerous other areas had water-damaged/missing ceiling tiles and damaged ceiling/wall plaster and efflorescence (i.e., mineral deposits), which are evidence of chronic water penetration from either the roof or plumbing system (Pictures 15 through 18/Table1). Active roof leaks were reported in the cafeteria, which were being addressed by a roofing contractor. Water-damaged ceiling tiles can provide a source of mold and should be replaced after a water leak is discovered and repaired. Efflorescence is a characteristic sign of water damage to building materials, but it is not mold growth. As moisture penetrates and works its way through building materials (e.g., plaster), water-soluble compounds dissolve, creating a solution. As this solution moves to the surface, the water evaporates, leaving behind white, powdery mineral deposits.

Water Damaged Ceiling and Wall Panels in Wood Shop

9. Ensure roof/window leaks are repaired and remove/replace any remaining water-stained ceiling tiles.
10. Remove all loose/hanging ceiling tiles to prevent falling hazards.

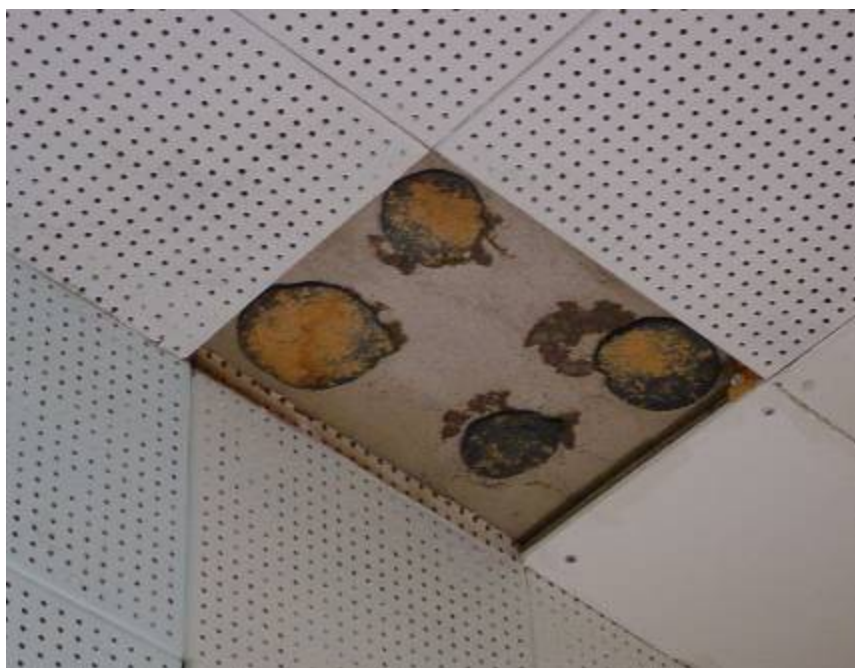
Picture 16

Missing/Water Damaged Ceiling tile

13. Replace missing ceiling tiles.
14. Replace damaged ductwork and gaskets to local wood dust collection system in wood shop to reduce airborne particulates.

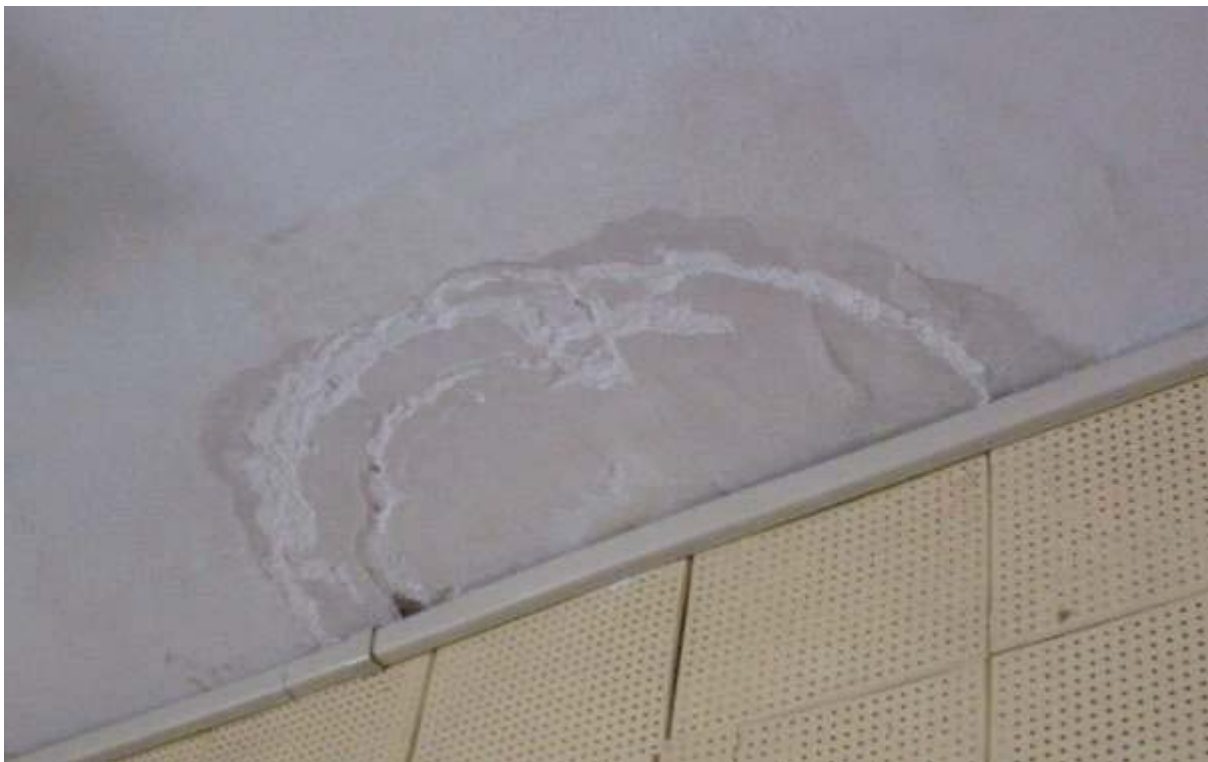
Picture 17

Water Damaged Ceiling Plaster and Efflorescence

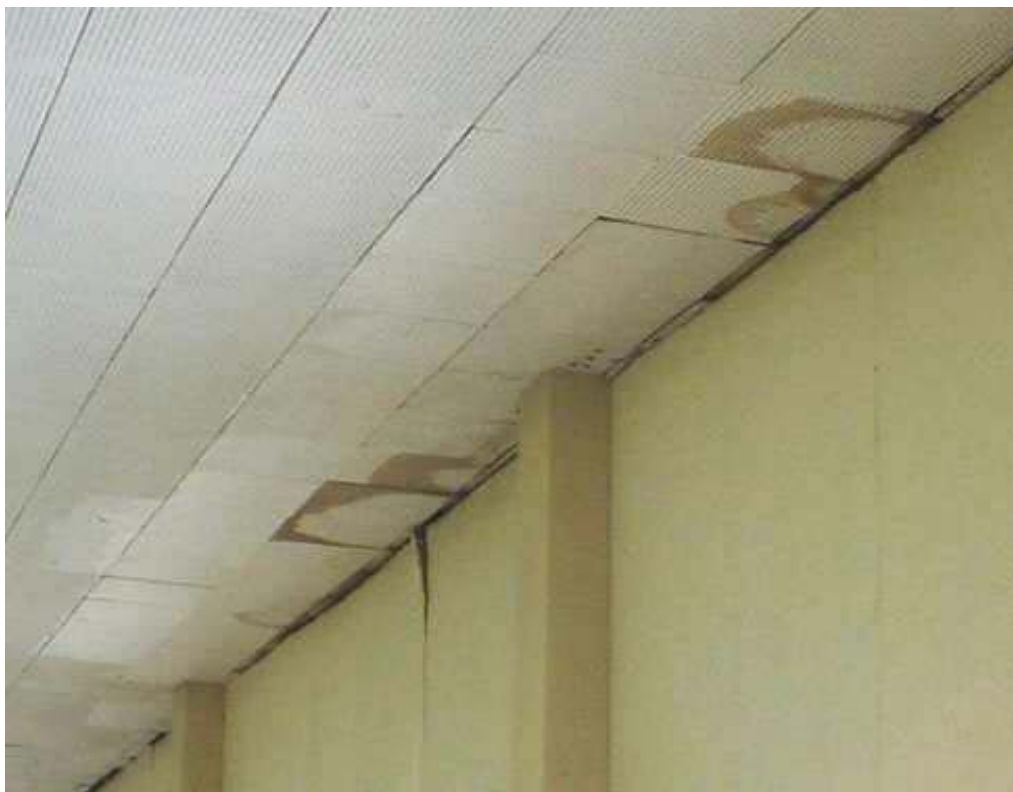
Picture 18

Water Damaged Ceiling Tiles along Exterior Wall

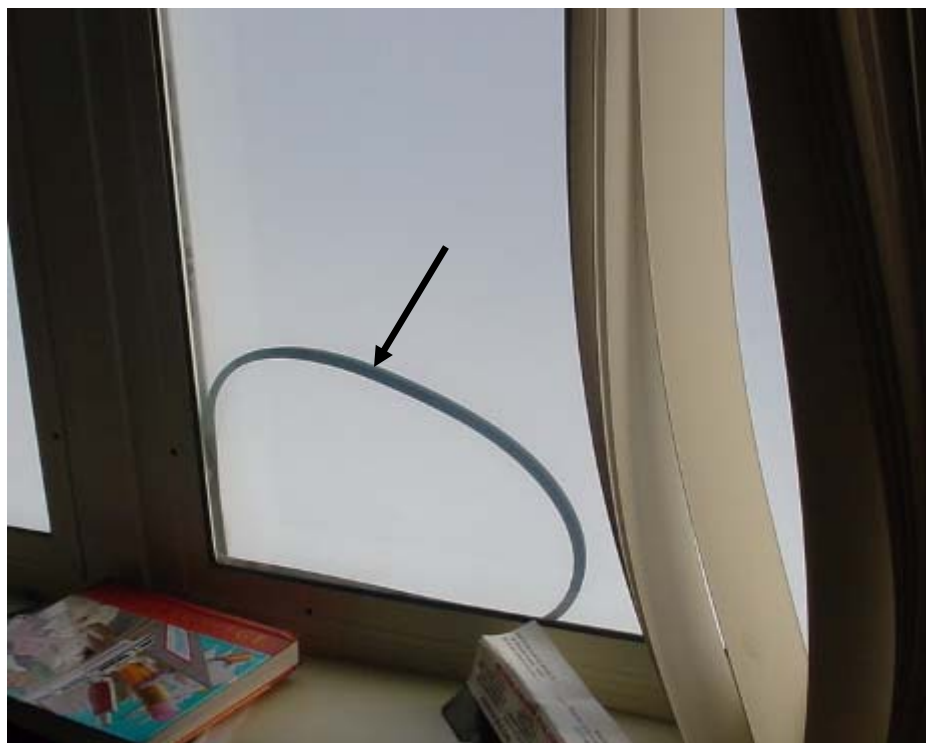
Picture 19

Missing/damaged/loose caulking was observed around windows and exterior wall panels (Pictures 19 through 23). Chronic water damage and air infiltration was noted around windows. Water penetration through window frames can lead to mold growth under certain conditions. Repairs of window leaks are necessary to prevent further water penetration, drafts and pest entry.

Loose/Damaged Window Caulking

11. Seal around windows and exterior wall panels to prevent water penetration, drafts and pest entry.
12. Relocate or consider reducing the amount of materials stored in classrooms to allow for more thorough cleaning of classrooms. Clean items regularly with a wet cloth or sponge to prevent excessive dust build-up.

3. Repair/replace loose/broken windowpanes and missing or damaged window caulking building-wide to prevent water penetration through window frames.

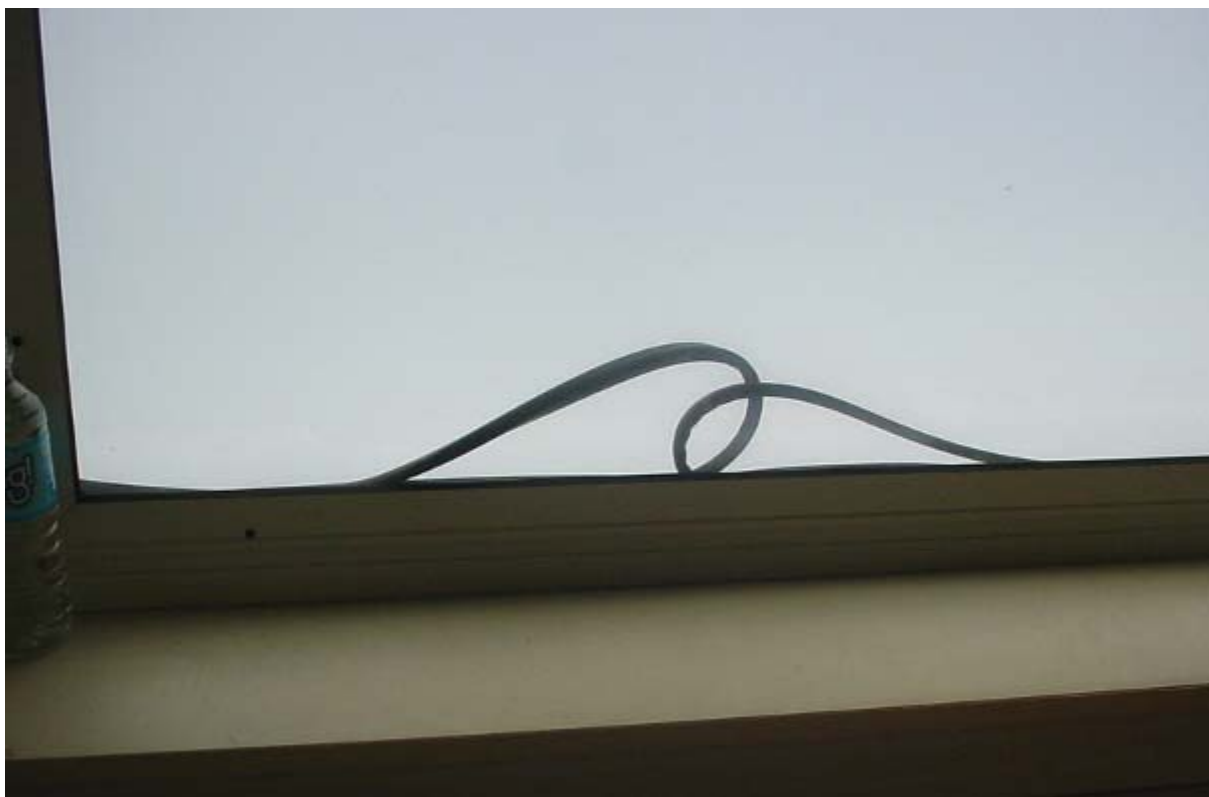
Picture 20

Loose/Damaged Window Caulking

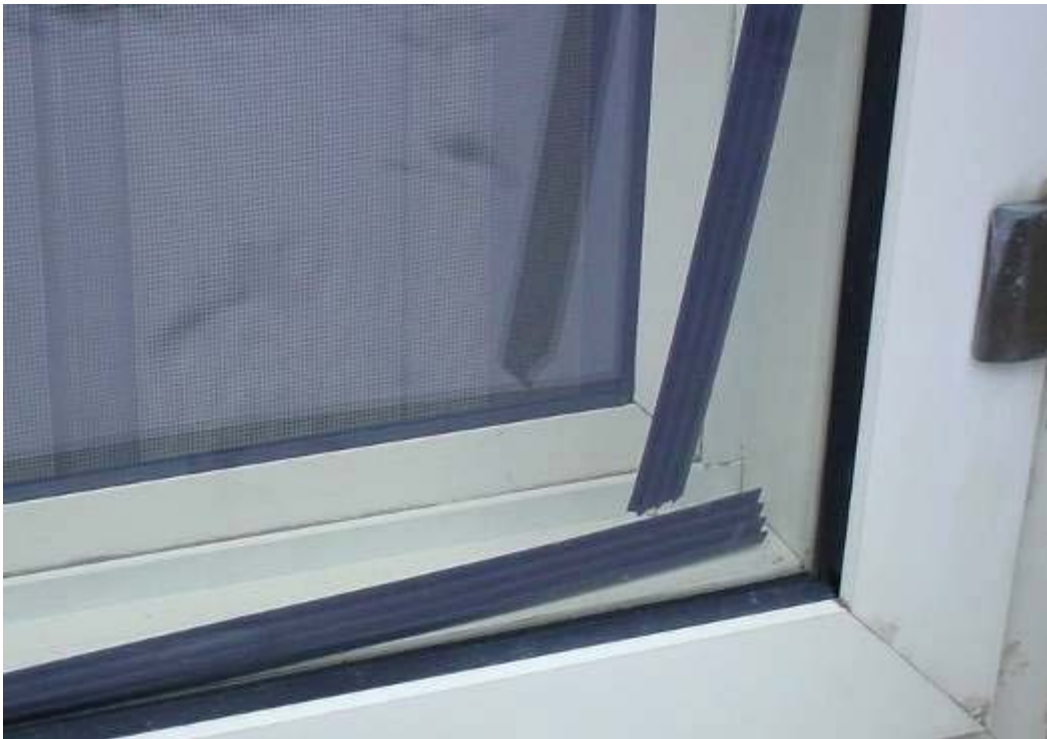
Picture 21

Loose/Damaged Window Caulking

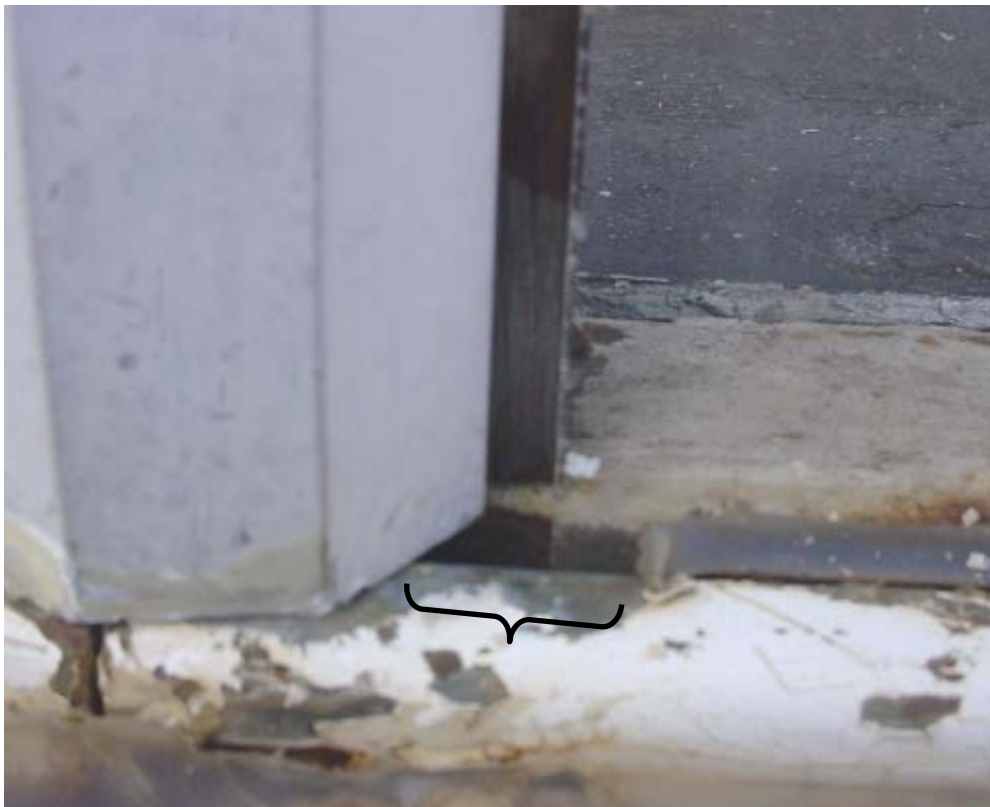
Picture 22

Missing Caulking Spaces between Glass Pane and Window Frame

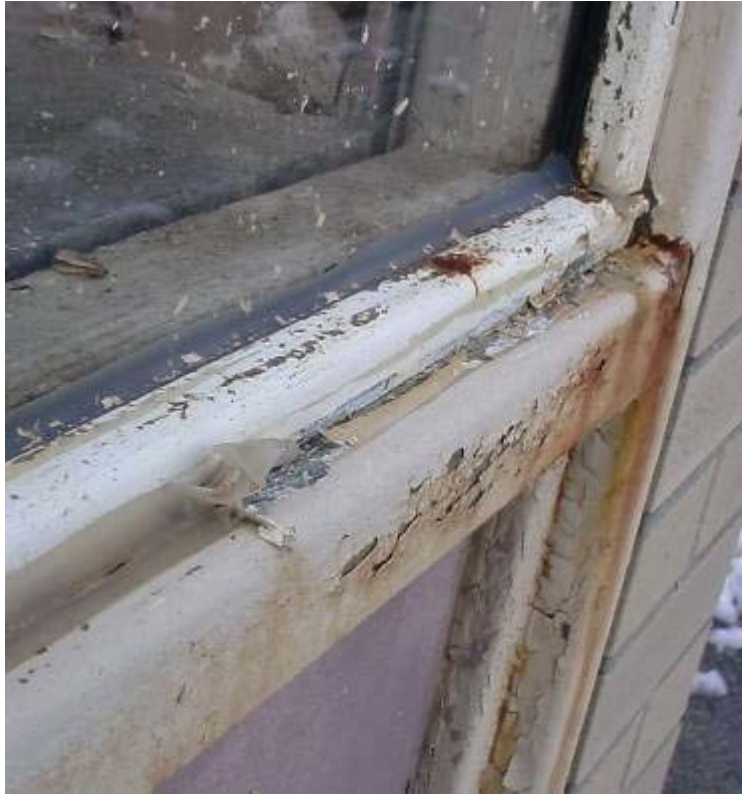
Picture 23

Missing Damaged Caulking around Exterior Wall Panels

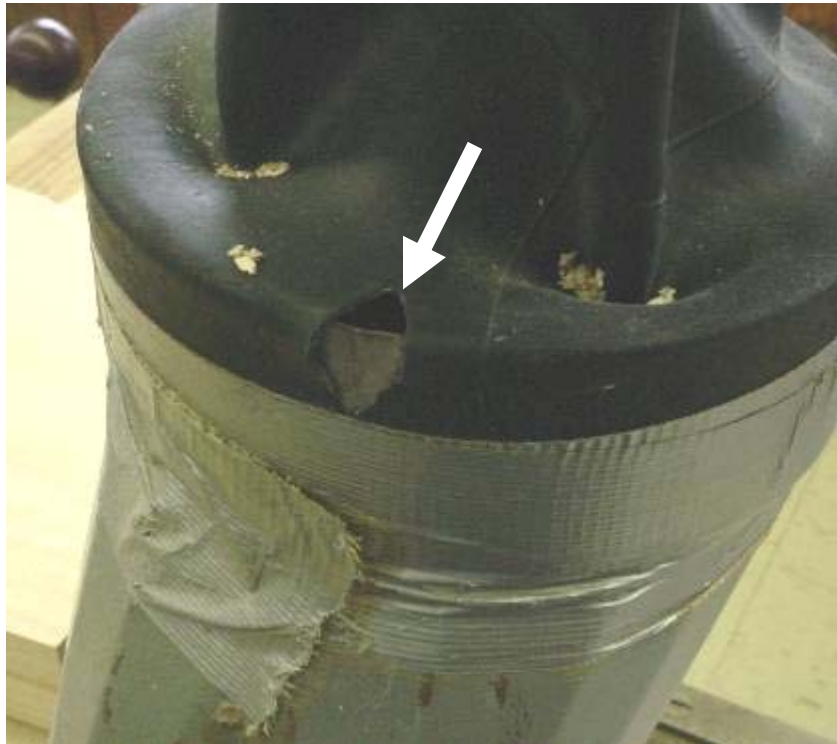
Picture 24

limited to particles generated during the operation of fan belts in the HVAC system, cooking in the cafeteria stoves and microwave ovens; use of photocopiers, fax machines and computer printing devices; operation of an ordinary vacuum cleaner and heavy foot traffic indoors. A likely source of airborne particulates was observed in the woodshop. Although the woodshop is equipped with a mechanical wood dust collection system, the system was found in disrepair, with damaged ductwork and gaskets and in some cases held together with duct tape (Pictures 24 through 26).

Local Exhaust System in Woodshop in Disrepair, Note Hole in Gasket and Duct Tape

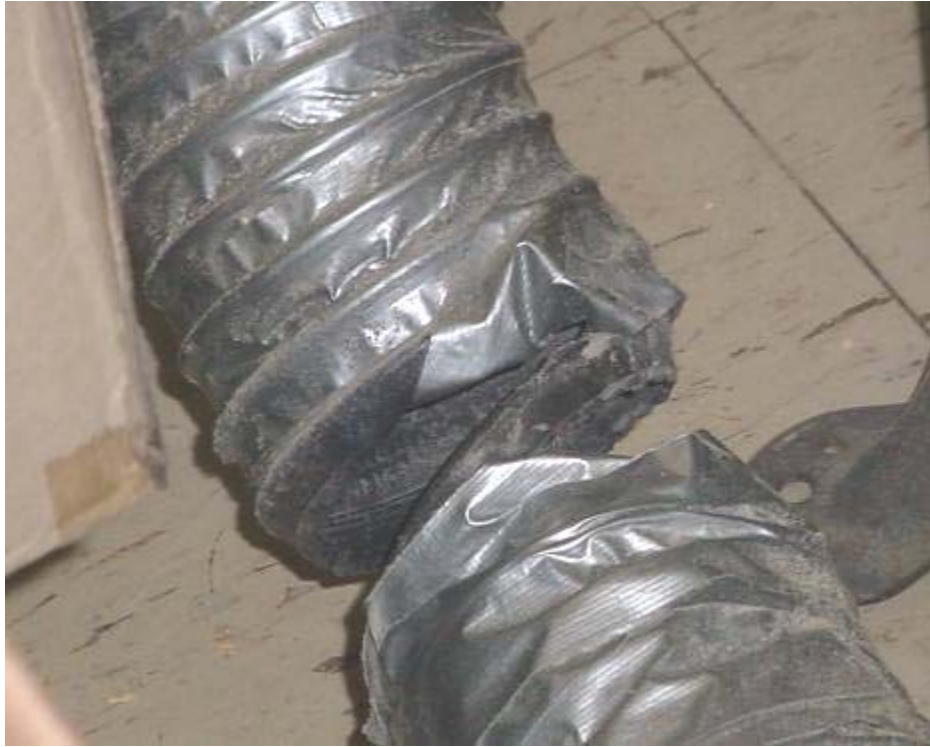
Picture 25

Damaged Flexible Duct to Woodshop Local Exhaust System

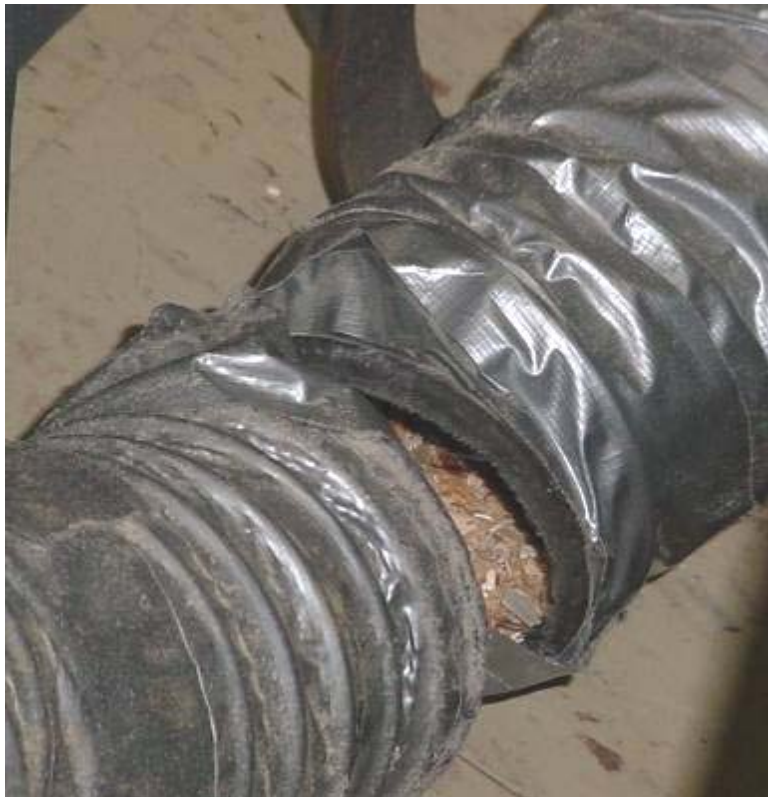
Picture 26

Damaged Flexible Duct to Woodshop Local Exhaust System, Note Wood Dust/Debris in Duct

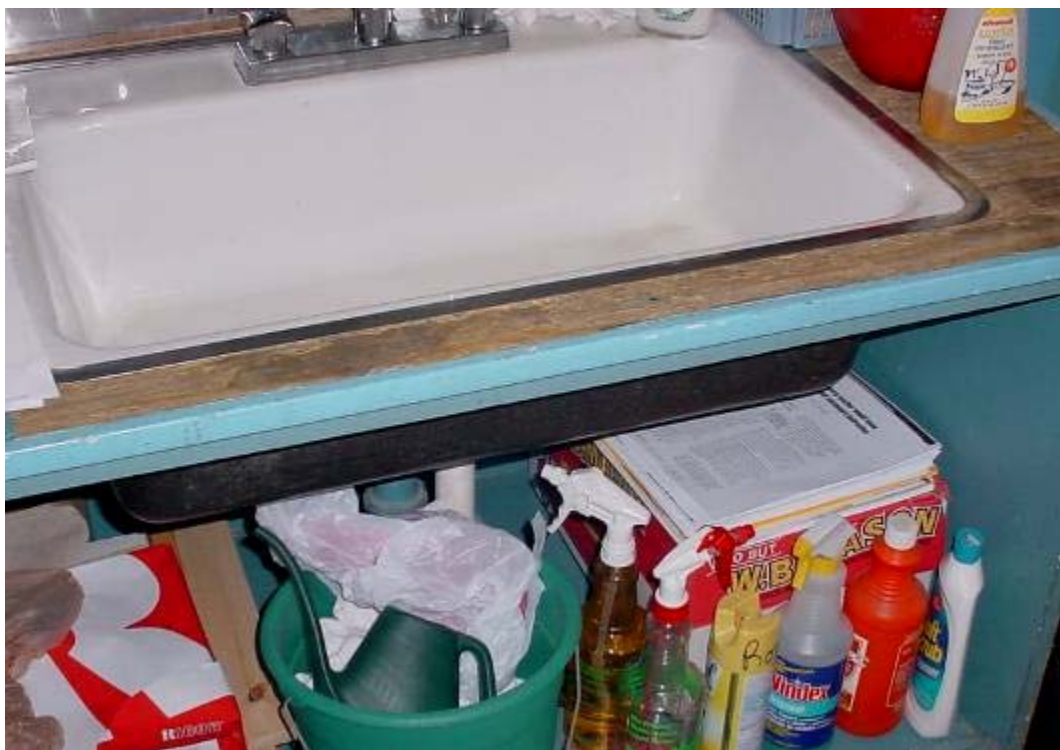
Picture 27

Spray Cleaning Chemicals under Classroom Sink

17. Store cleaning products properly and out of reach of students. Ensure spray bottles are properly labeled. *All* cleaning products used at the facility should be approved by the school department with MSDS' available at a central location.
